Manhole Inspection Summary

Manhole # S27A__015MH

Location Address: **REAR OF 625 EDMONSON AVE** Cross Street: **FREMONT AVE**

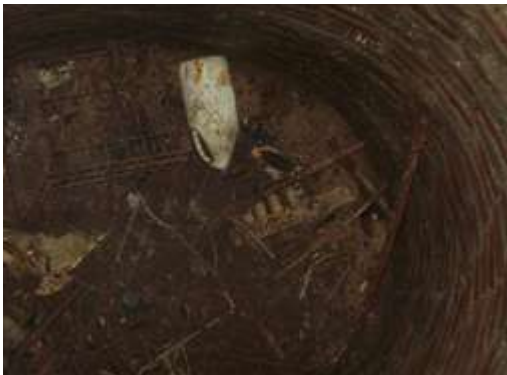
Defect 2

DEBRIS ON BENCH

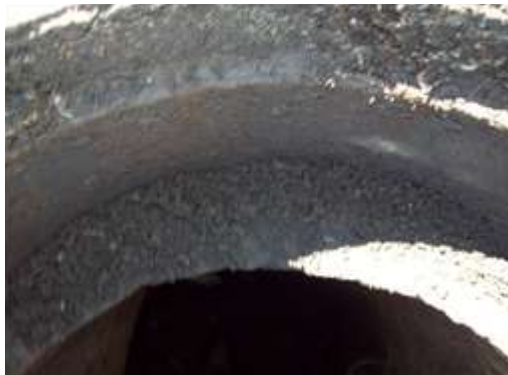
Defect 1

Frame Offset: **4** (in.) Condition: ☒ Sound ☐ Cracked ☐ Leaks

FRAME OFFSET

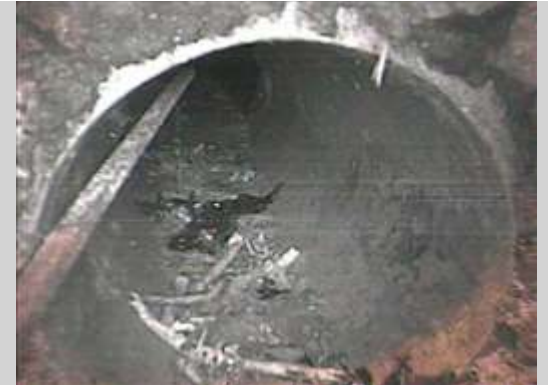
12 O'Clock Outflow

8 in. Circular Gravity Sewer
Pipe Out @ 12 O'Clock

Infiltration: **None** Pipe Seal Cond: **Cracked**
